FLOOD RESISTANT HOUSING

LOW-COST DISASTER-RESISTANT HOUSING IN BANGLADESH

technical brief

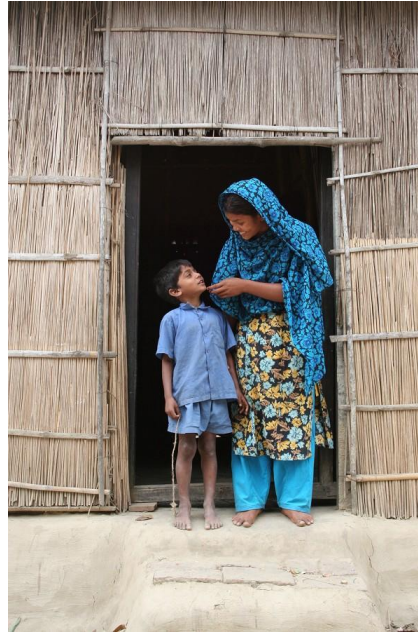
Figure 1: Hosne Ara (14 yrs) and Faruq Hussein (10 yrs) live with their parents in Wazuddin Fakirer Dangi, The house is built on a raised plinth made from sand, clay and cement. Photo: Practical Action Bangladesh.

The house is built on a raised plinth made from sand, clay and cement (meaning it is less likely to be washed away in floods), and made using concrete pillars and treated bamboo poles. Strong and high enough to last through repeated floods, unlike the traditional earthen floors that simply wash away.

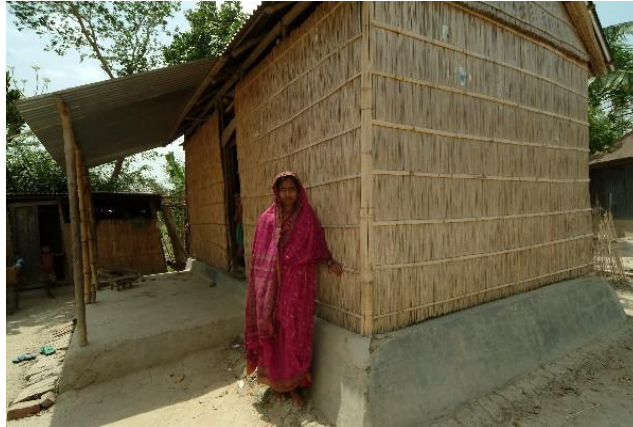
Figure 3: Julekha Begum is the owner of this house in Yasin Mirdhar Dangi, Faridpur. Photo: Practical Action Bangladesh.

Jute panels make resilient walls that cost very little yet are quick and easy to replace. Treated bamboo poles on concrete bases are strengthened with metal tie rods to hold the wall firm and safe. Treated jute stick woven mat partitions increase durability.

The structure, with woven bamboo walls, can be dismantled in the case of a forecast severe flood, and moved for re-erection on a new site or restoration after floodwaters subside.

Bracings and fastenings bind the walls firmly to the house ‘skeleton’ through a network of holes and notches – locally called a ‘clam system’ – and the whole building can stay standing through the strongest of winds and rain. Nuts and bolts, screws, ties and nails are required.

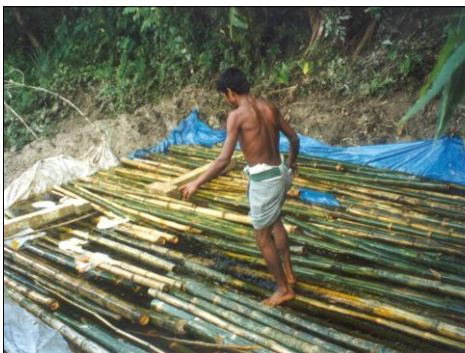
Figure 4: Curing bamboo trees for building flood resistant houses Faridpur, Bangladesh. Photo: Practical Action Bangladesh.

Bamboo poles are treated to make them more resilient to flooding so that they last longer.

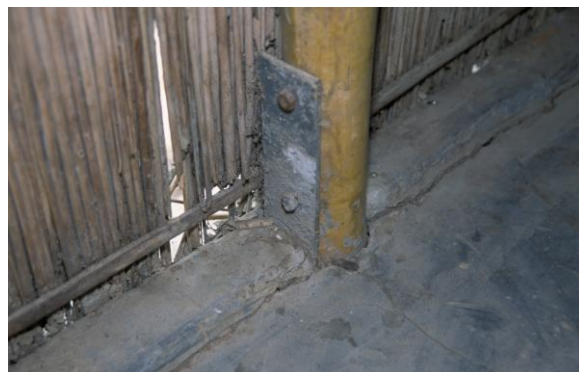
Figure 5: detail of the footing. Photo: Practical Action Bangladesh.

Reinforced concrete posts with footings were introduced to strengthen the structure. Short reinforced concrete stumps for the treated bamboo posts make the structure more resilient to the water.

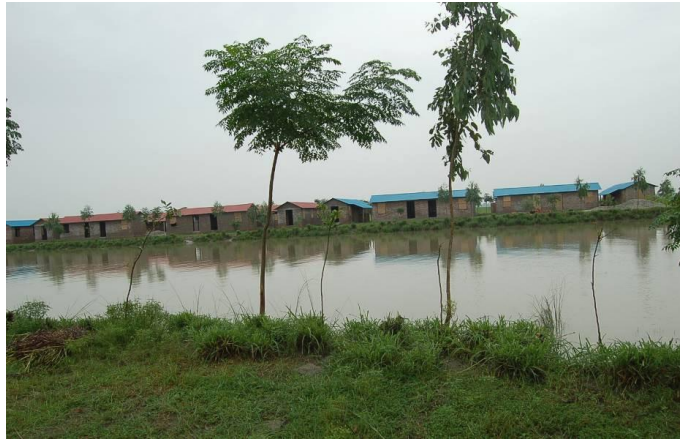
Figure 6 : A completed cluster village with pond for community fish culture. Photo: Practical Action Bangladesh.

Another integrated approach taken up by Practical Action was the resettlement of dam dwellers through the development of cluster villages where the whole village was built on raised land. 500 decimal (1 decimal is equal to 1/100 of an acre or approximately 40.46 m²) of land was acquired that was large enough to contain a small village, of up to about 100 houses and the height of earth embankment was determined by considering the flooding records for the previous 40 years i.e. ground level of cluster village should be 3 feet or 900 mm above the highest flood level.

The cluster village is made in a collaborative way; people excavate soil and sand from one area to build an earth platform. This is done in the dry season December to April. The hole where the soil/sand is excavated from creates a reservoir which is used by the community for various livelihood initiatives such as fish farming, duck rearing, floating gardens etc.

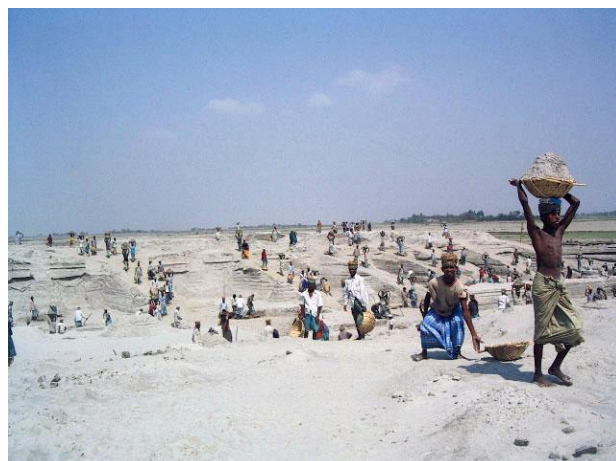
Figure 8: The whole community work together to make a large raised platform for the cluster village.
Photo: Practical Action Bangladesh.

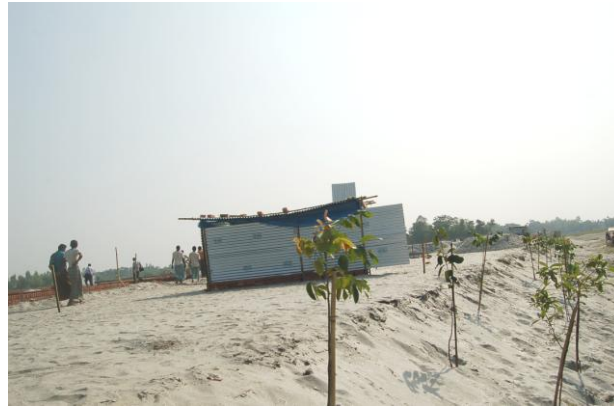
Figure 9: The newly finished earth raising is planted with young trees to stabilise the sandy soil. Photo: Practical Action Bangladesh.

The banks are stabilised by planting fruit trees and Napier grass (which can also be used as goat/sheep fodder).
